Debris/Ice/TPS Assessment and Integrated Photographic Analysis for Shuttle Mission STS-51

October 1993

Gregory N. Katnik
NASA/Kennedy Space Center

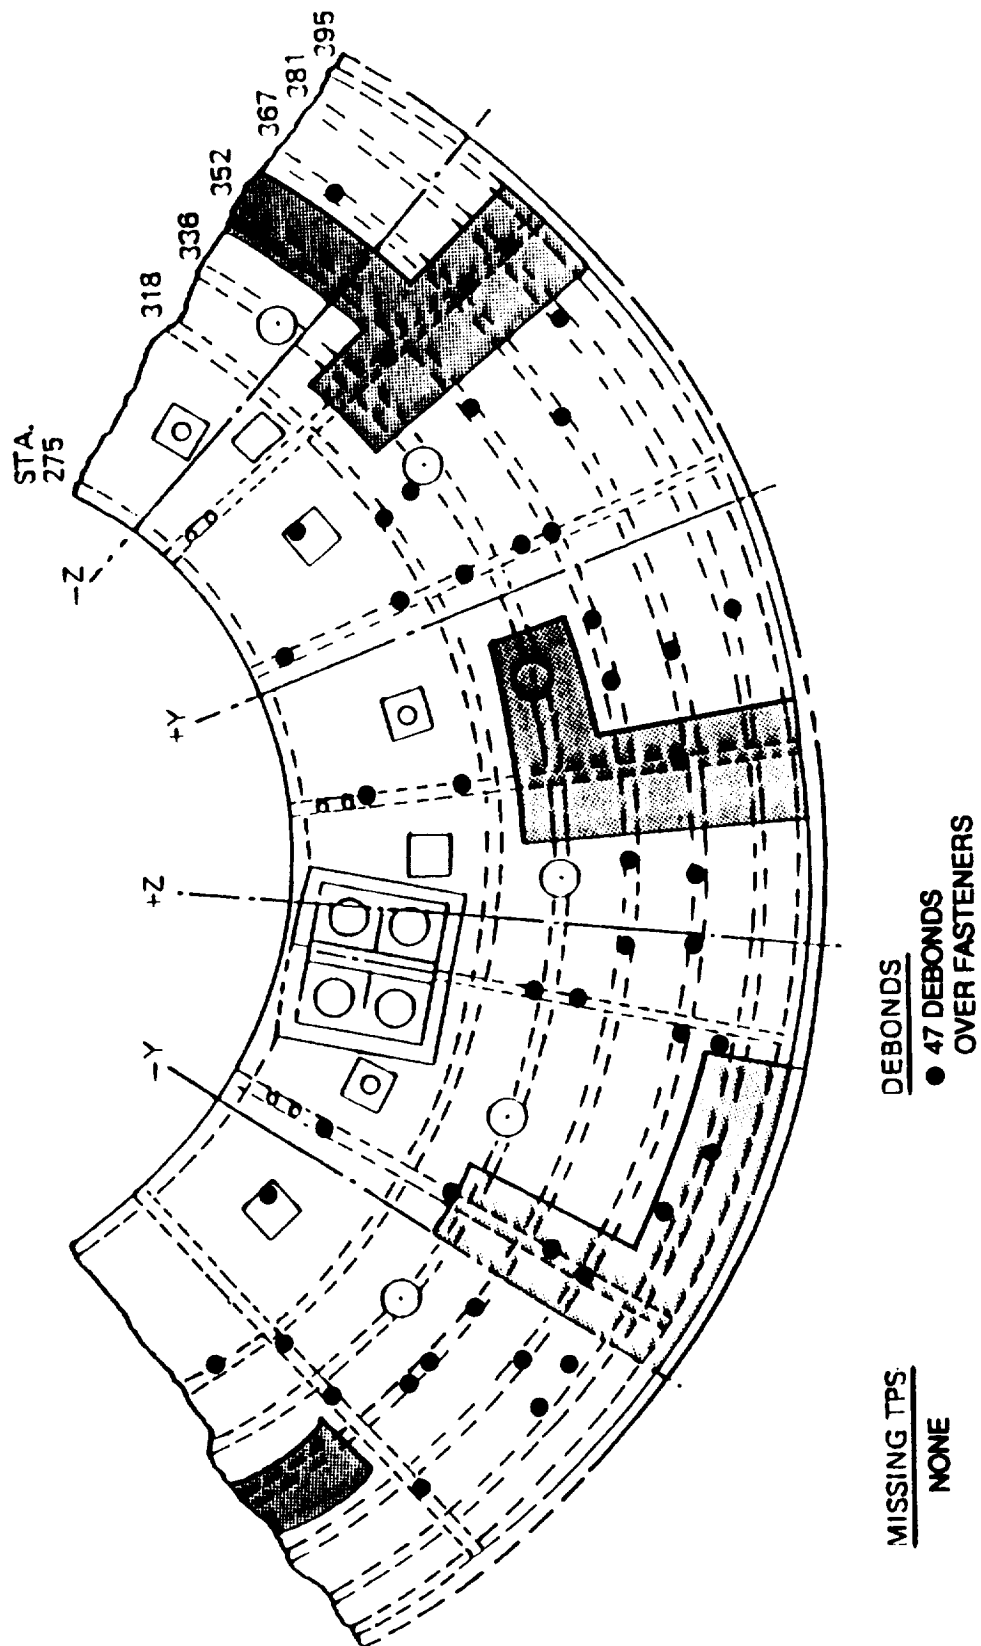
FIGURE 11. RIGHT SRB FRUSTRUM

The RH frustum had 47 MSA-2 debonds over fasteners. Minor blistering of the Hypalon paint had occurred in localized areas (Figure 11). All BSM aero heatshield covers were locked in the fully opened position.

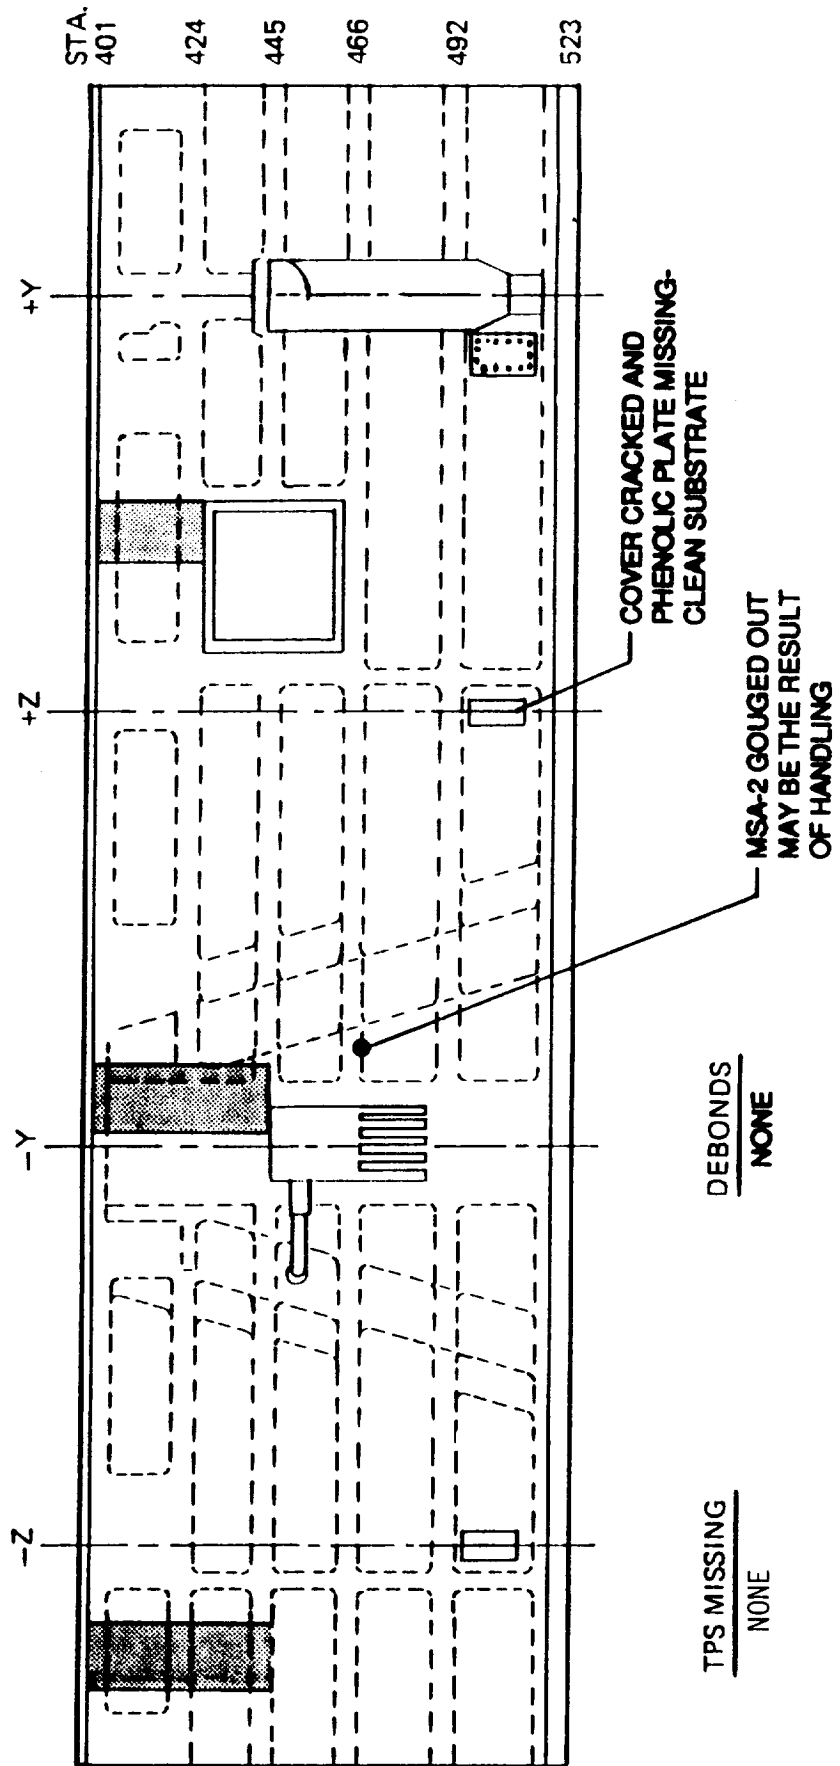
FIGURE 12. RIGHT SRIB FWD SKIRT

The RH forward skirt acreage had two small MSA-2 divots as a result of handling. There were no MSA-2 debonds. The -Z RSS antenna cover/phenolic base plate was intact. The +Z RSS antenna cover was damaged and the phenolic base plate was missing. The substrate was not sooted and the damage most likely was the result of nozzle severance debris impact. Minor blistering of the Hypalon paint occurred on the systems tunnel cover and around the ET/SRB attach point (Figure 12). No pins were missing from the frustum severance ring. The forward separation bolt appeared to have separated cleanly.

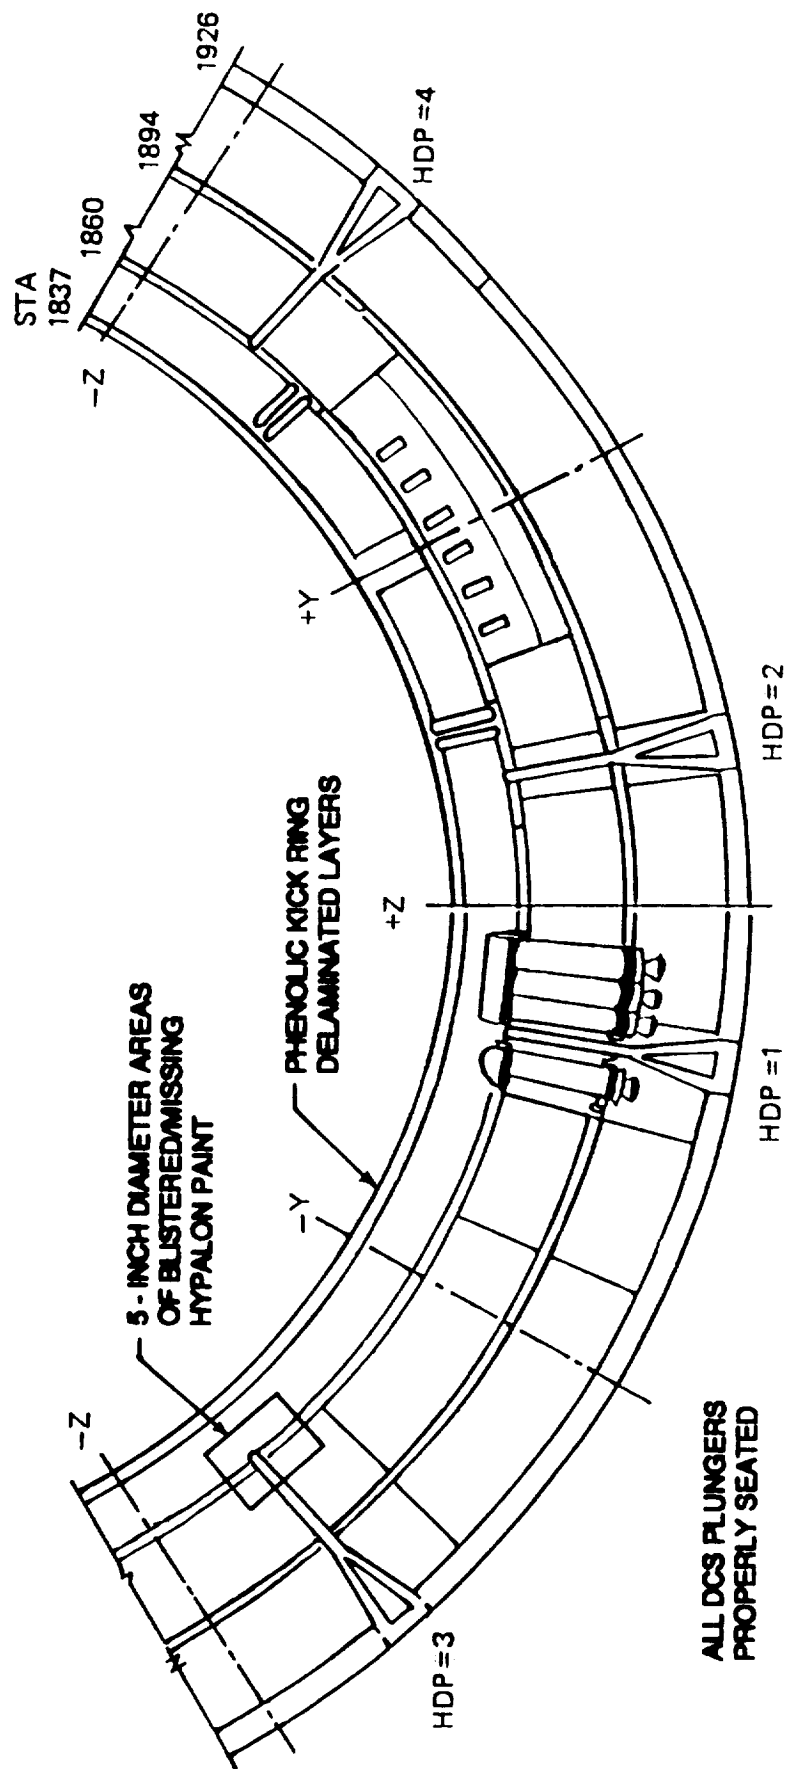
FIGURE 13. RIGHT SRB AFT SKIRT EXTERIOR TPS

All four Debris Containment System (DCS) plungers were seated and appeared to have functioned correctly. The EPON shim material was intact during liftoff and flight (Figure 13).

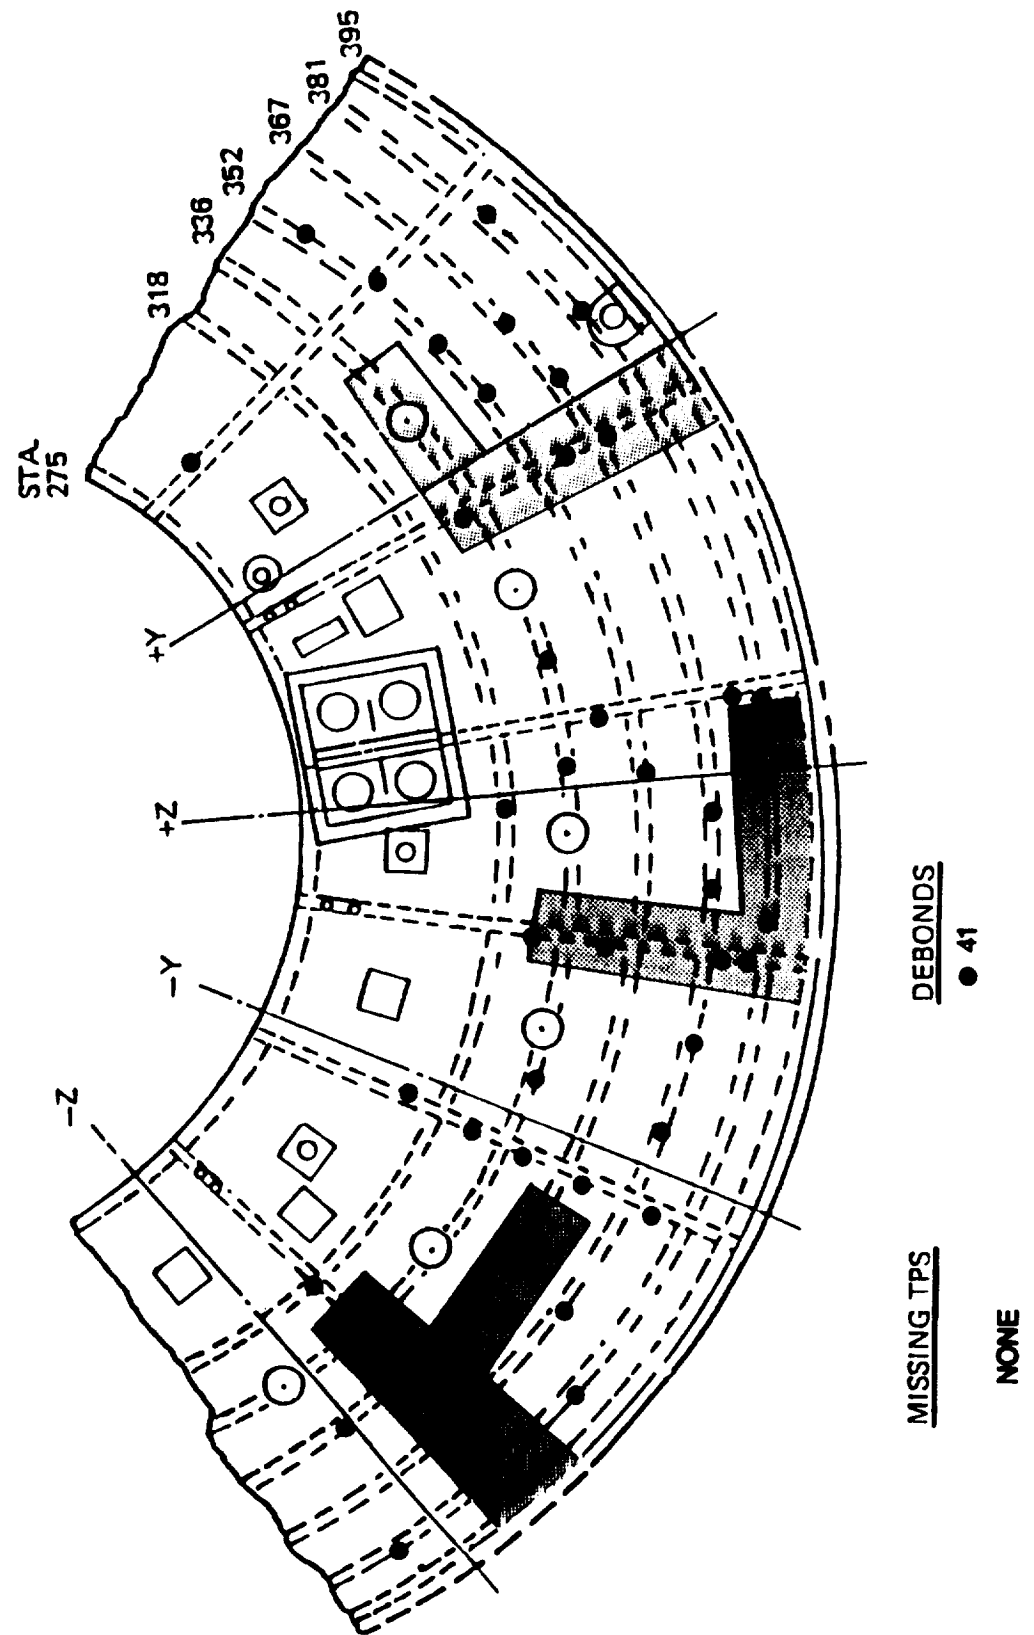
FIGURE 14. **LEFT SAB FRAUSTUM**

The LH frustum was missing no TPS, but had 41 MSA-2 debonds over fasteners. Minor localized blistering of the Hypalon paint had occurred in localized areas (Figure 14). The BSM aero heat shield covers were locked in the fully opened position.

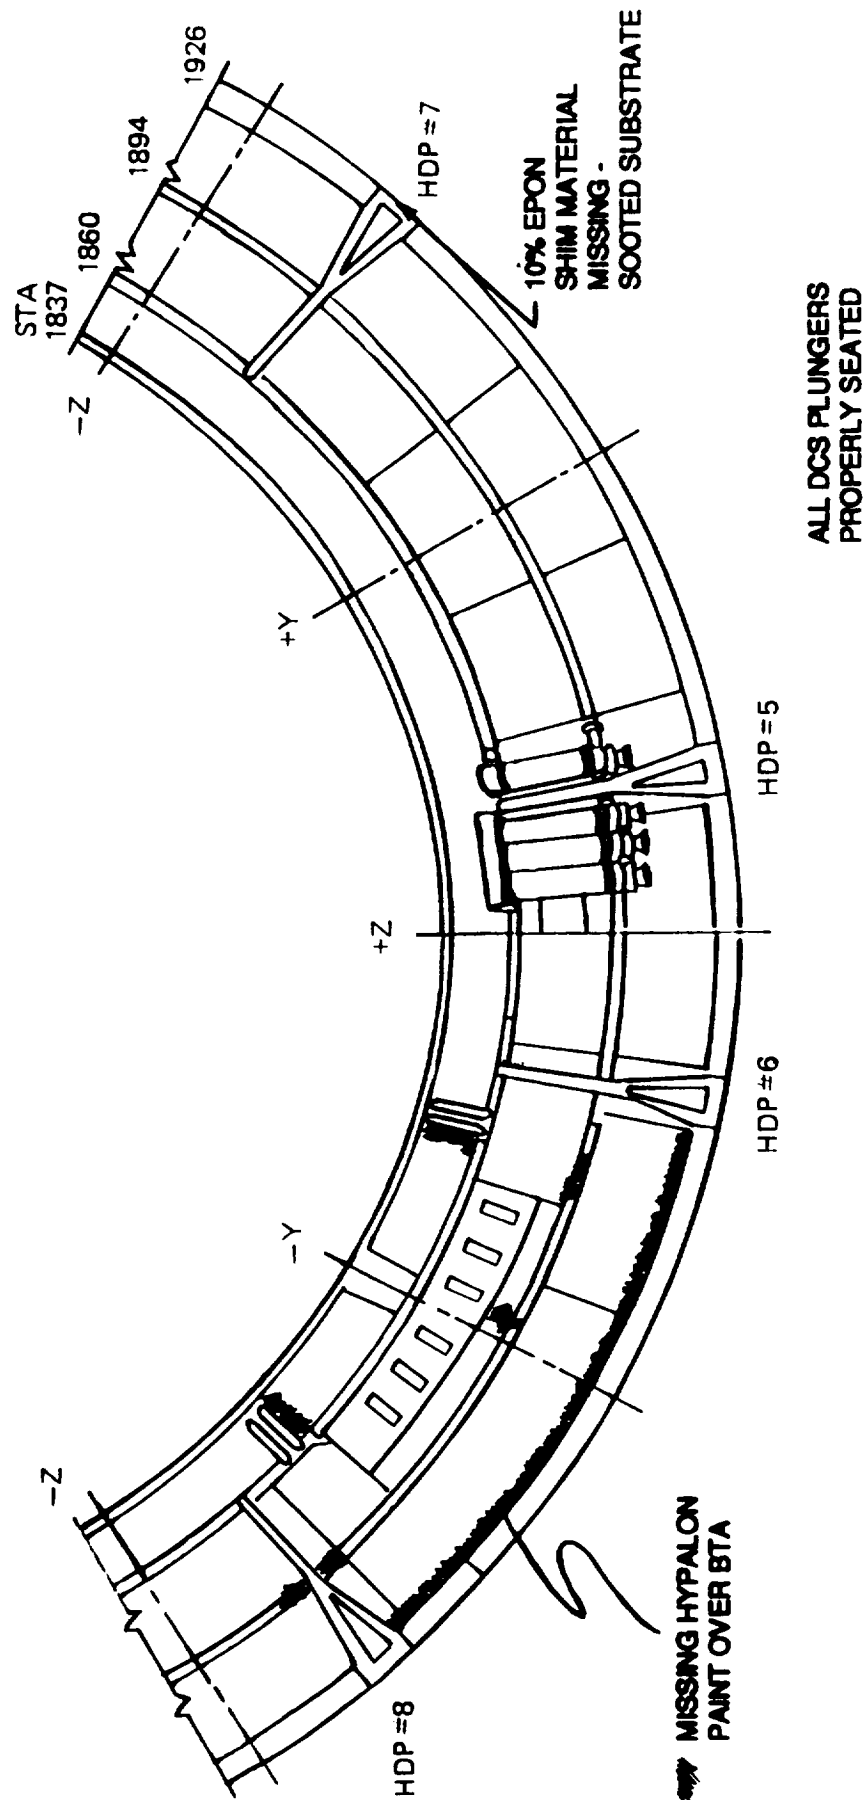
FIGURE 15. LEFT SRB AFT SKIRT EXTERIOR TPS

Hypalon paint was extensively blistered and/or missing from numerous areas of Booster Trowellable Ablator on the aft skirt - IFA STS-51-B-2 (Figure 15). The Hypalon paint is used as a topcoat to prevent moisture intrusion prior to launch, but is not required for thermal protection during flight. The IFA was closed based on the rationale that blistering and/or loss of Hypalon in flight will not cause significant Orbiter tile damage due to the light mass/density of the topcoat. Practical application history has shown that blistering and loss of Hypalon occurs most frequently when multiple coats of the paint were applied during preflight processing. A change to the application procedure may specify only one, thin coat of Hypalon.

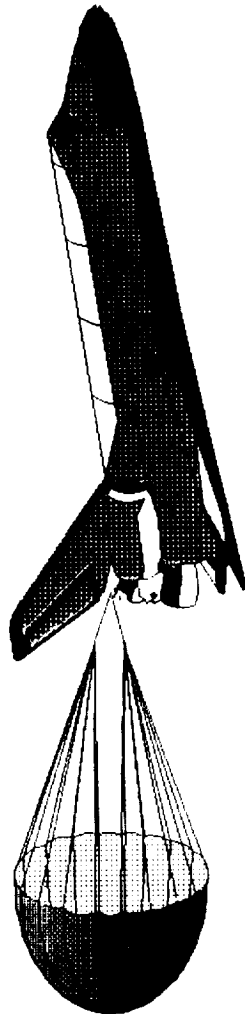
FIGURE 20.

The post landing walkdown of Runway 15 was performed immediately after landing. All Orbiter drag chute hardware, with the exception of the mortar cover, was recovered and showed no signs of abnormal operation (tenth use of the Orbiter drag chute in the Shuttle program). The cover was not found during a more detailed daylight search. No organic (bird) debris was found on the runway. Four Q-felt plugs, most likely from the base heat shield area, were recovered in the vicinity of the drag chute door (Figure 20).

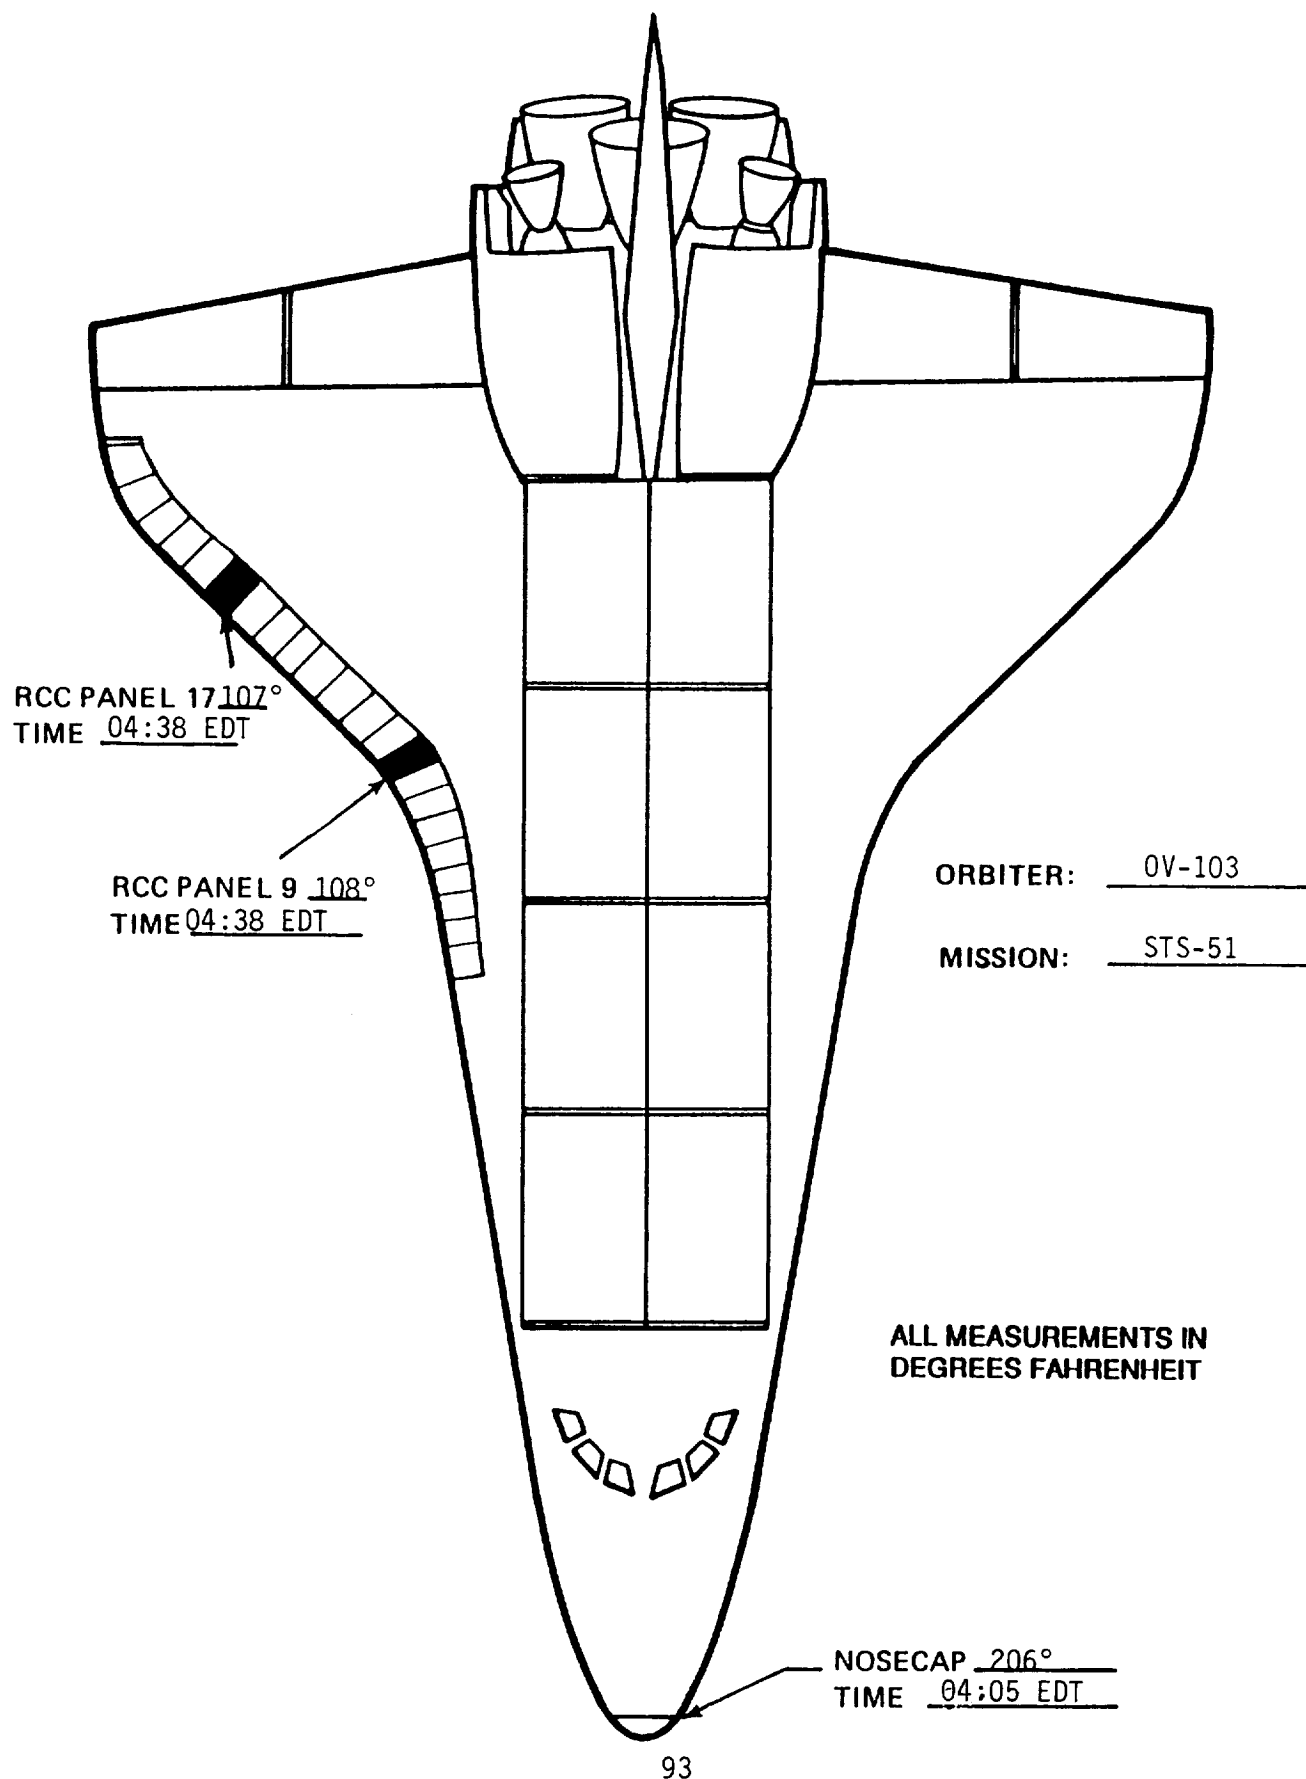
FIGURE 21. **STS- 51 RCC TEMPERATURE MEASUREMENTS AS
RECORDED BY THE SHUTTLE THERMAL IMAGER**

The Shuttle Thermal Imager (STI) was used to measure the surface temperatures of several areas on the vehicle (per OMRSD V09AJ0.095). Nine minutes after landing, the Orbiter noscap RCC was 206 degrees F. Forty-two minutes after landing, the RH wing leading edge RCC panel #9 was 108 degrees F and panel #17 was 107 degrees F (Figure 21).

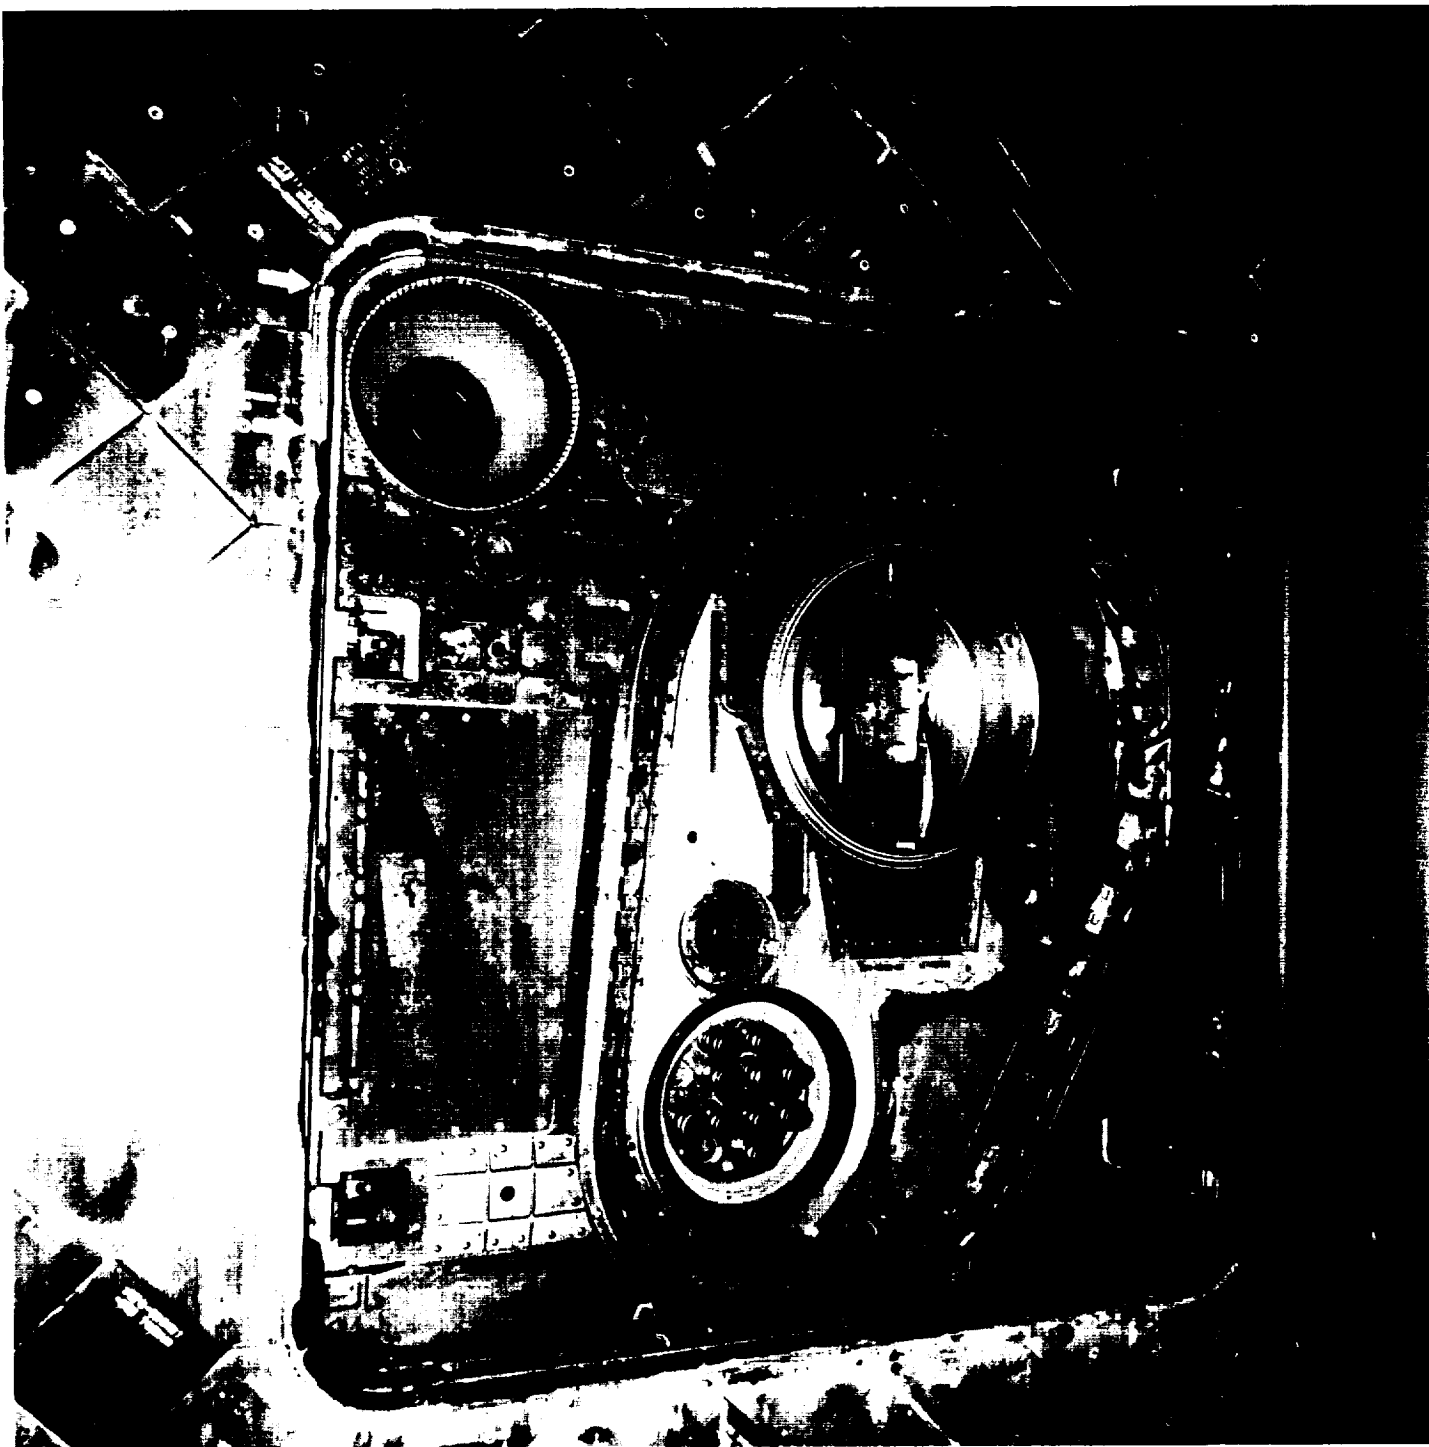
Overall view of the LO2 ET/ORB umbilical. All separation ordnance devices functioned properly. No flight hardware was found on the runway below the umbilical when the ET door was opened.

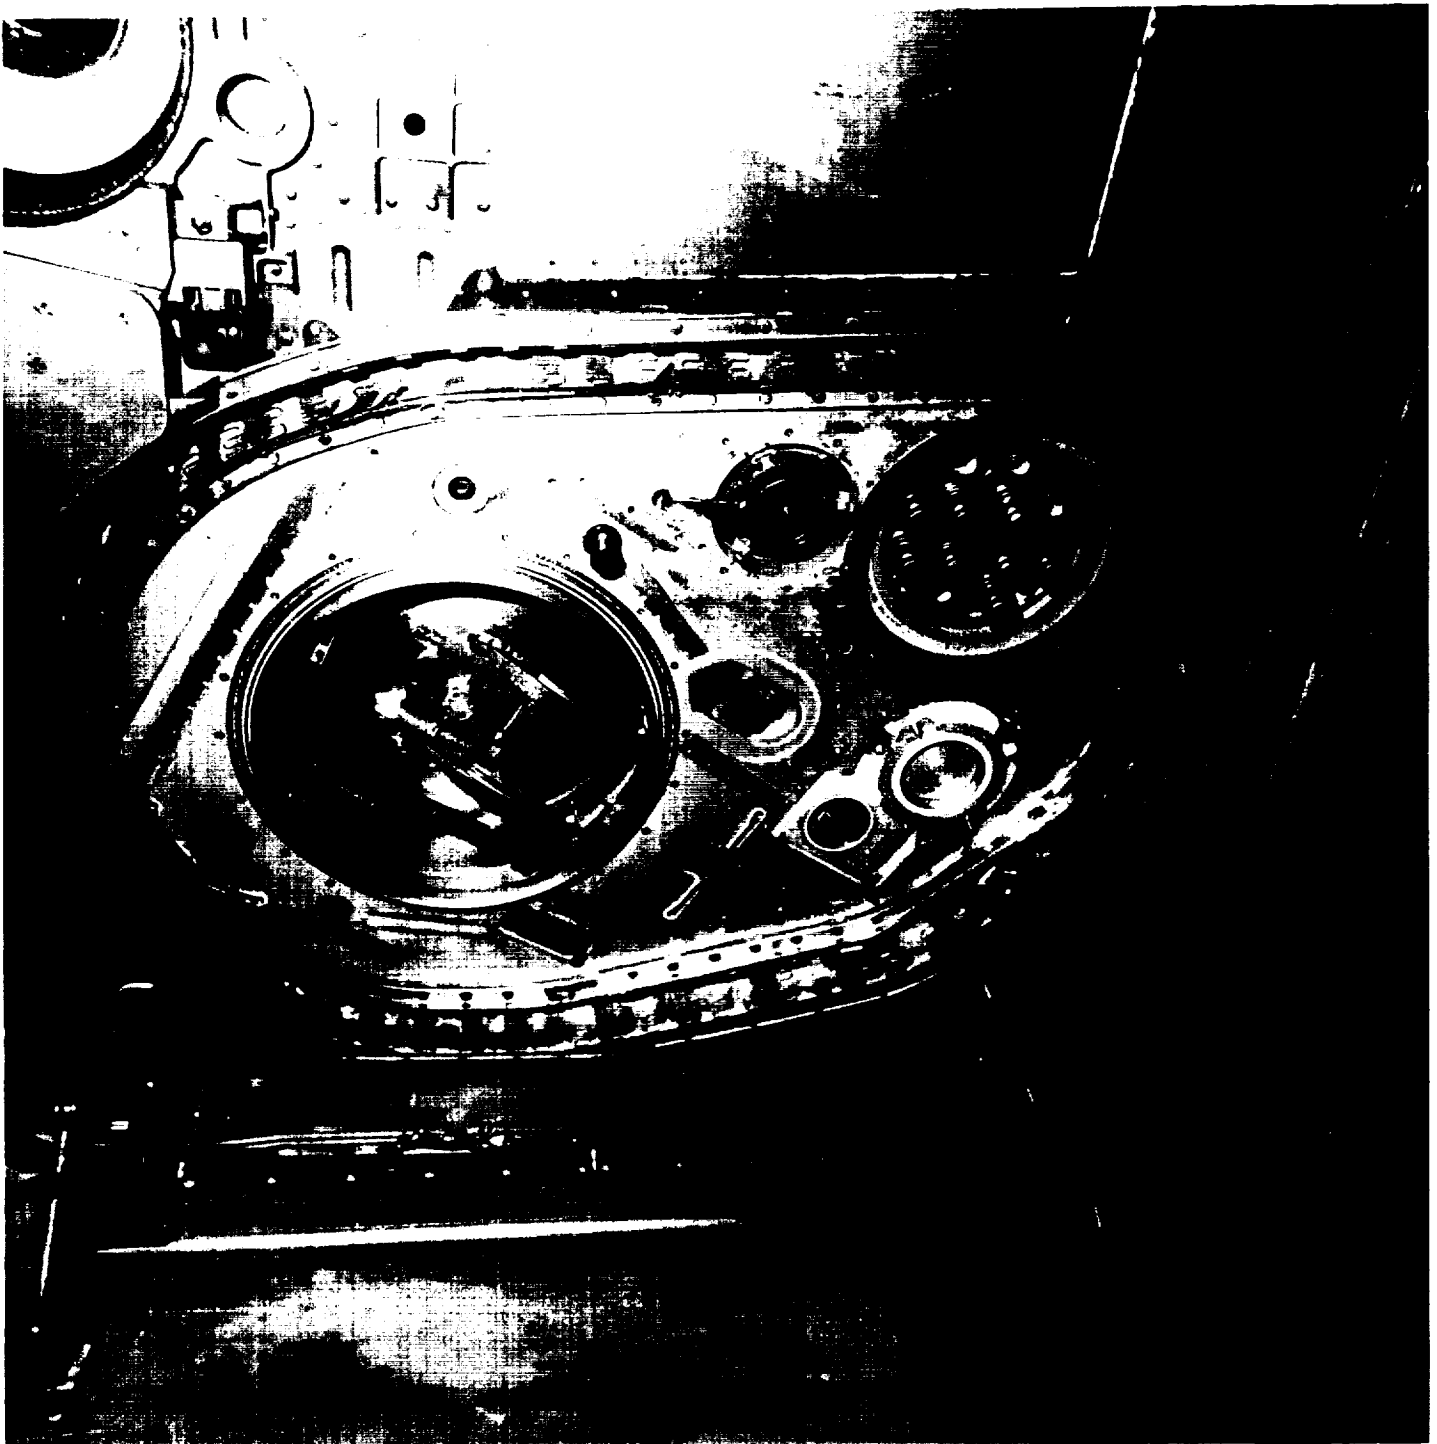
Overall view of the LH2 ET/ORB umbilical. All separation ordnance devices functioned properly. No flight hardware was found on the runway below the umbilical when the ET door was opened.

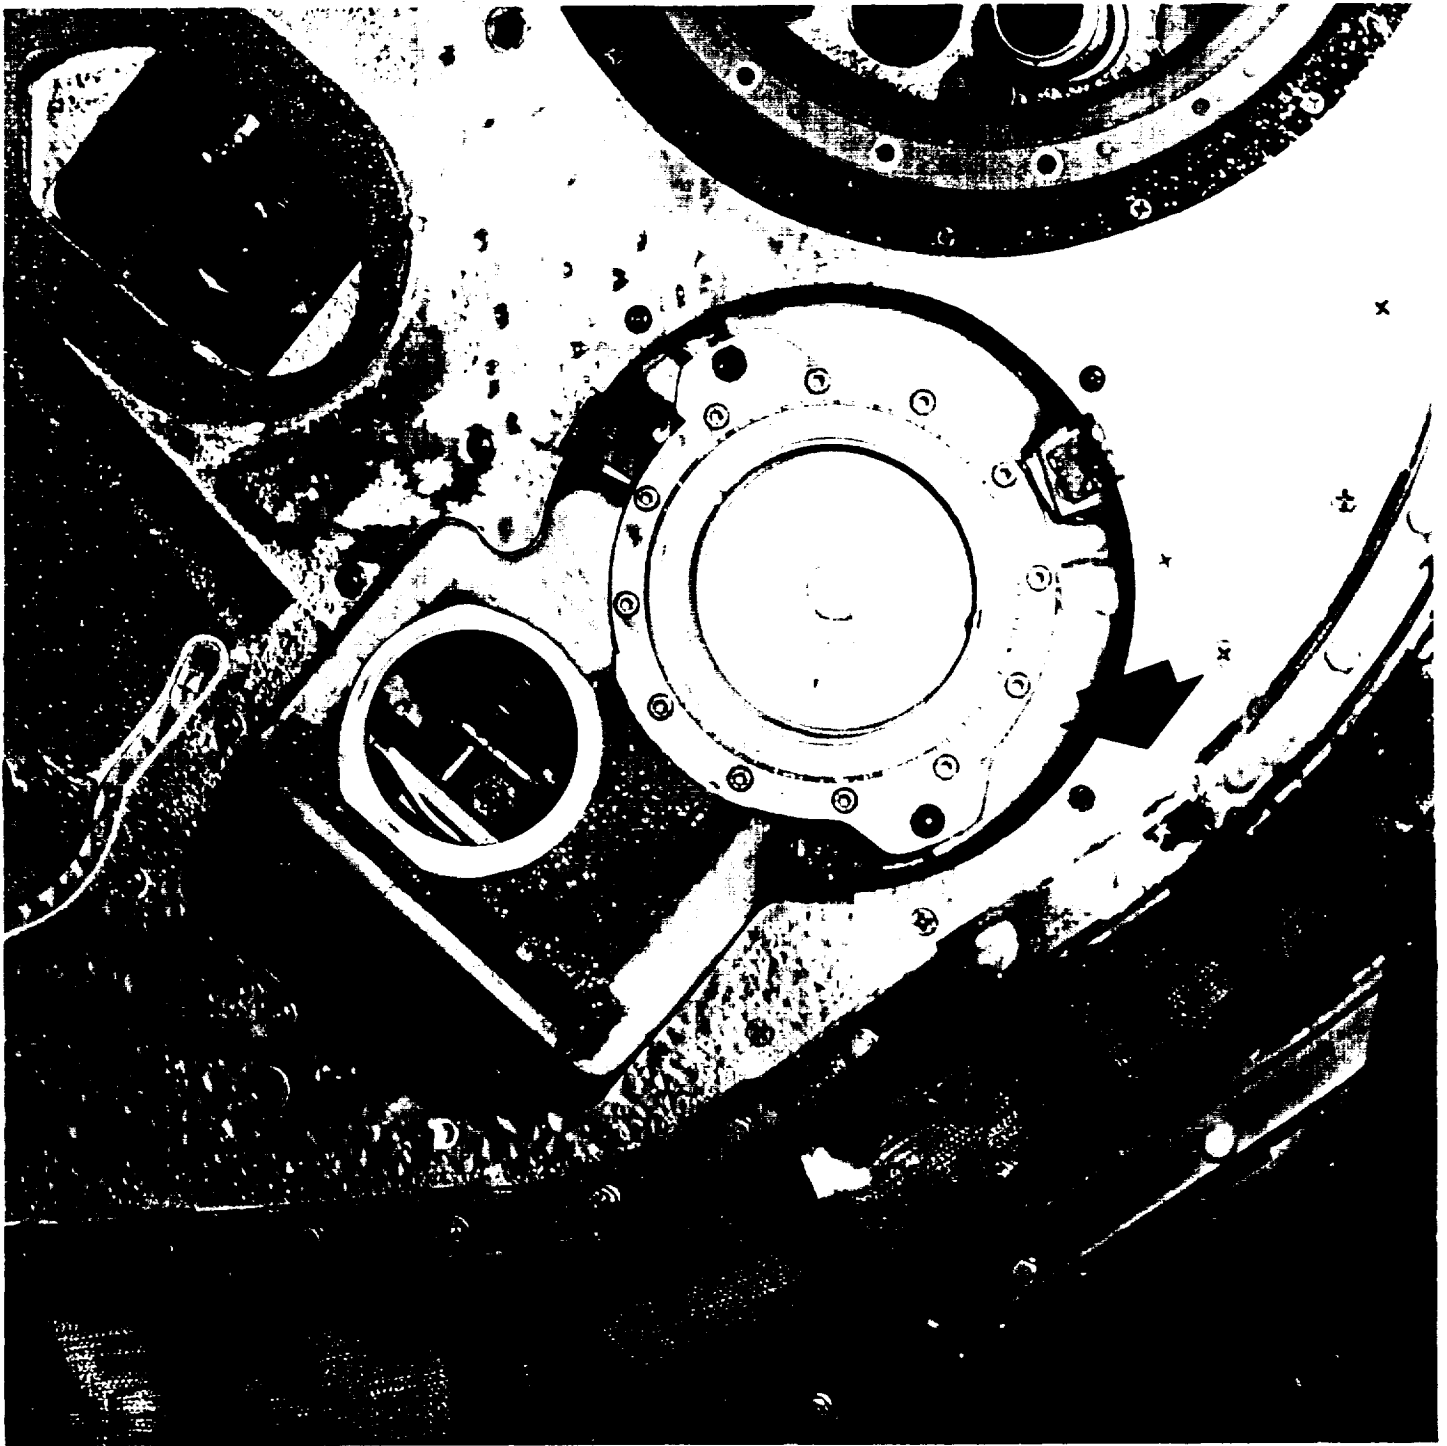
No red purge seal or significant amounts of ET foam adhered to the LH2 ET/ORB umbilical plate near the LH2 4-inch line flapper valve.

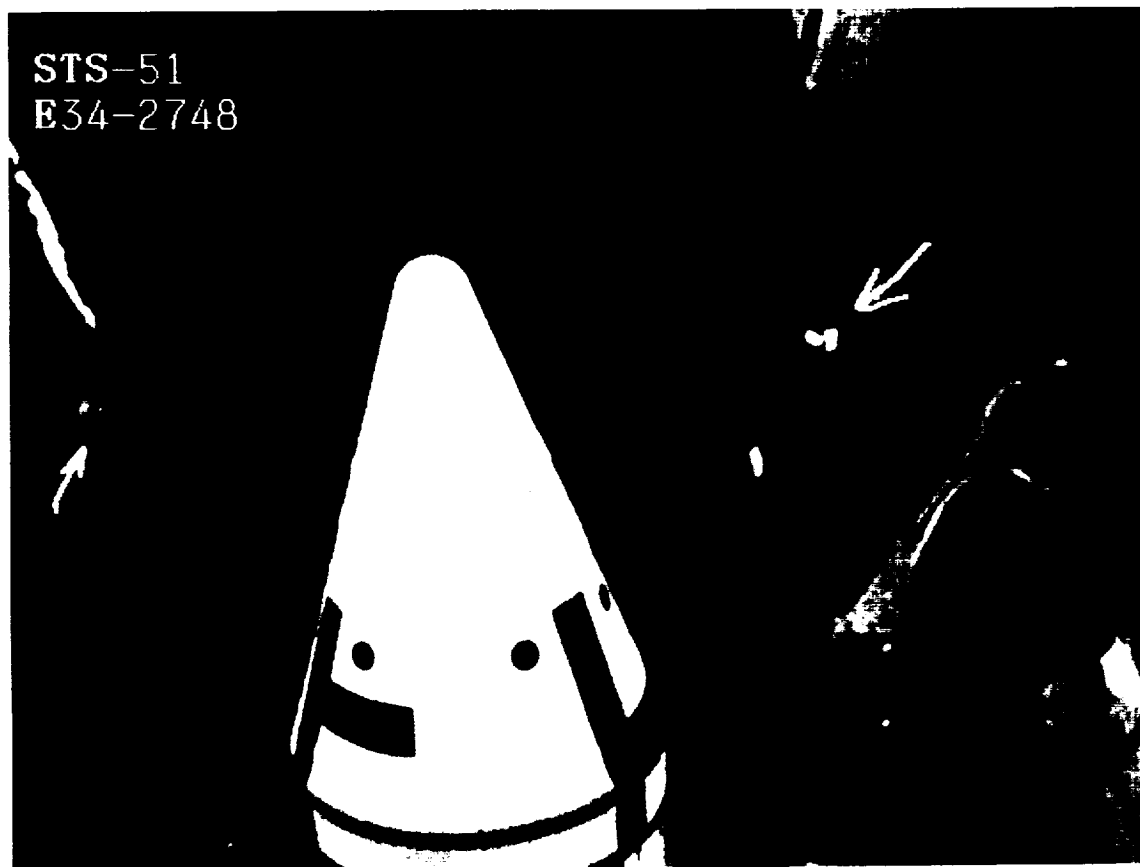
Figure 2.2.2 Vapors noted from ET Intertank Purge Vents

Vapor was noted coming from the external tank intertank +Z and -Z purge vents (approximately 180 degrees apart) at T-2.799 to T-1.363 seconds prior to liftoff. Venting from these purge vents has not been seen on previous mission launch films. This event was reviewed with KSC, Martin Marietta, and the MER. No follow-up action has been requested.

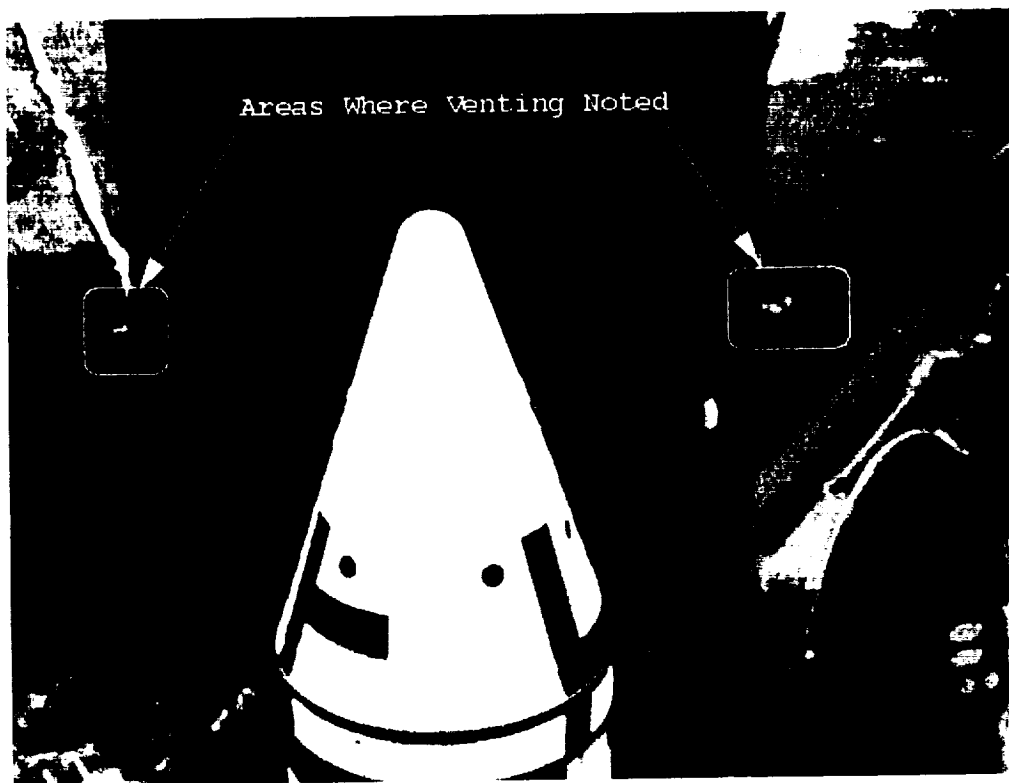
Figure 1.

Figure 1 is a frame of film taken from camera E-34 showing venting from the external tank. After correlating this view with views of the same event on cameras E-62 and E-63 it was determined that the most likely source of the venting was the ET intertank aero vent. Review of previous launch films show this type of venting occurs when atmospheric conditions are similar.

Venting from ET Intertank Aero Vent
